CASE STUDY

Technowrap repair to 24 inch ammonia line, South Africa

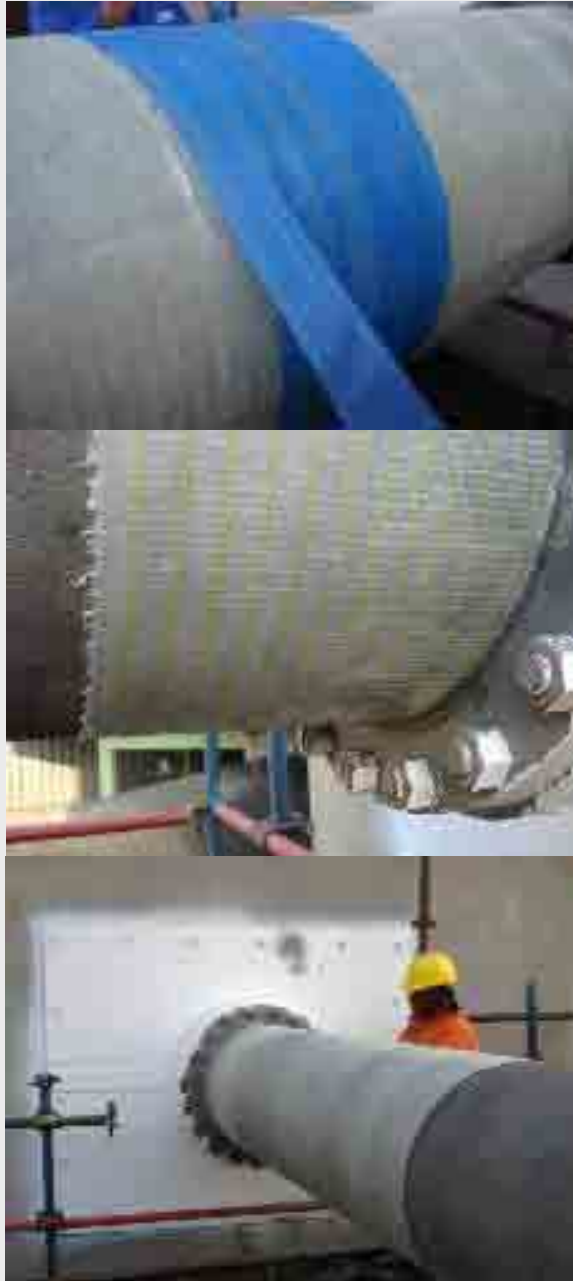
Refinery in Secunda South Africa, experienced excessive internal erosion. Pin hole leaks had formed expelling ammonia into the atmosphere. Technowrap was asked to provide a solution.

The line was isolated whilst the repair was implemented. The preparation was to Sa 2.5 provided by the client. Technowrap sealing compound was used to close up the holes, and afterward the Technowrap 2k HA was applied.
